TECHNICAL SERVICES BULLETIN

Long Haul Steer Tire Shoulder Wear

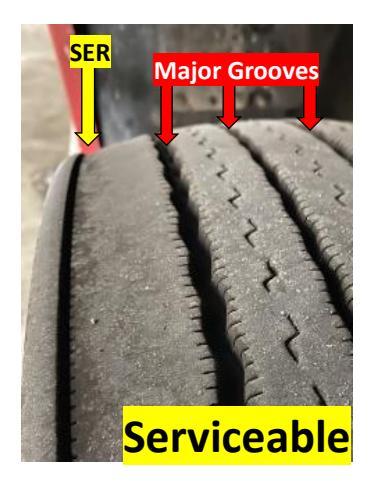
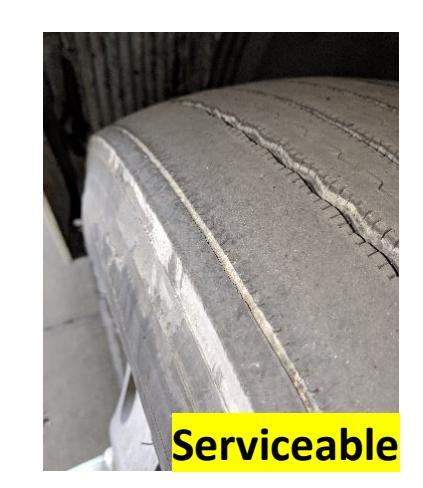
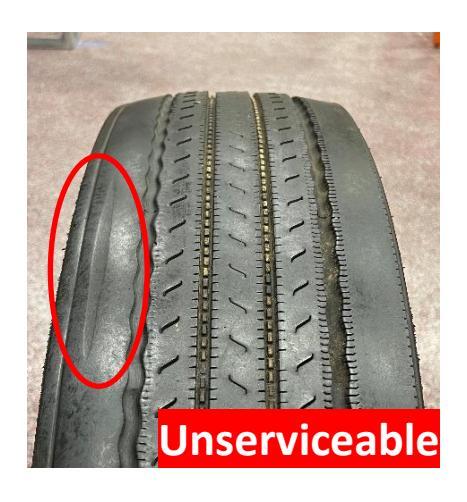
When irregular wear does occur, it does not necessarily mean there is a loss of performance in the tire that warrants removal. When evaluating irregular wear, it is important to consider the remaining depth of the major grooves and whether any effects are manifesting in vehicle handling. *Poor appearance does not always mean poor performance*. If none of the major grooves are below the fleet's tread depth removal point and there is not an effect felt in handling, then such wear may not be a good reason for removal.

The shoulder defense groove is not considered a major groove, does not have treadwear indicators, and it is not appropriate to use for tread depth measurements. Wear in this area does not warrant removal except in the extreme case where undertread material is exposed (photo at far right, above).

Proper alignment and steer pressure maintenance are critical for achieving uniform wear patterns and maximizing the life of tires used in long haul service.

When aligning a vehicle for long haul service it is important to conduct a full vehicle alignment including the steer and drive axles. Non-uninform steer wear can be a result of misalignment from either the steer or drive axles. Misalignment related steer wear most commonly appears as shoulder wear on one side of the tire. This occurs from lateral forces scrubbing the side of the tire that is fighting to keep the truck straight against that misalignment. Misalignment related sided shoulder wear may appear on one or both of the steer tires.
